# Prevention of Turtle's Access to the Road: Specifics of the Environmental Impact Assessment Conditions and Measures Issued for the Priority Objects from the National Linear Infrastructure Network in Bulgaria

**Abstract:** Mortality by vehicular traffic is a well-documented, worldwide threat to chelonian populations. We present a detailed analysis of the conditions and measures for prevention of turtle mortality included in the Environmental Impact Assessment (EIA) decisions for important road constructions issued between 2008 and 2016 by the competent authority (the Ministry of the Environment and Waters, MoEW) of Bulgaria. We identified seventeen EIAs issued for priority objects of the national road network that have been finalized or are currently under construction. All EIA decisions contained specific instructions for protecting the turtle populations, including avoiding damage to eggs, nests or adults during the construction phase, avoiding fragmentation of the populations, limiting access of animals to the road to prevent direct collisions with vehicles. We focused on the instructions included in every EIA decision concerning the design of the constructions preventing acce

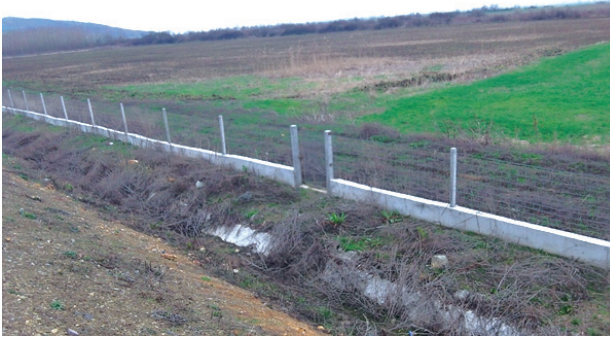
**Fig. 1.** Concrete walls for protection of vehicular turtle mortality at Trakiya Motorway. Note the gap in the wall where the service door is mounted

Other older documents also prescribe the construction of extended concrete walls to stop turtles (EIA DECISION № 14-2 2009, AA DECISION № 104 2009, EIA DECISION № 5-3 2010). Actually, according to our experience, building of concrete walls has proven impractical and has a lot of disadvantages. In fact, the concrete walls suffer severe construction flaws. The long walls have to be periodically disrupted by "expansion joints". These joints are necessary, because concrete is not thermally stable and shrinks and swells depending on the climatic conditions. Another downside of the concrete walls is shown on Fig. 1 and 2. These figures represent the only ever build concrete walls for turtle protection in Bulgaria. The obligate "rabbit nets" along motorways should be equipped with both small and large hinged doors for access by maintenance vehicles (LoR 2012). Since such equipment cannot cross the concrete walls, the walls are interrupted in uneven sections. We assess the efficiency of such constructions in preventing turtles to appear on the asphalt as very low. We also have to stress that

concrete walls may be dangerous in cases of vehicular accidents on the road.

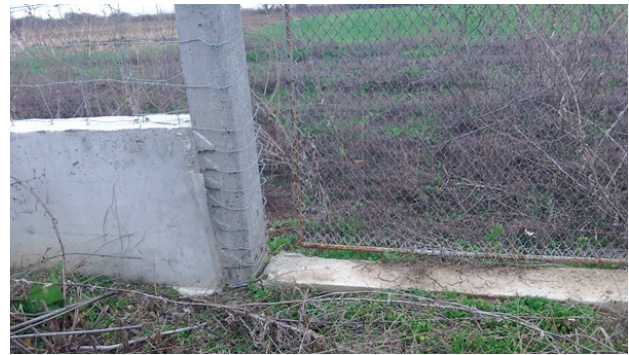
**Fig. 2.** Close-up of the service door built in the concrete walls for protection from vehicular turtle mortality at Trakiya Motorway

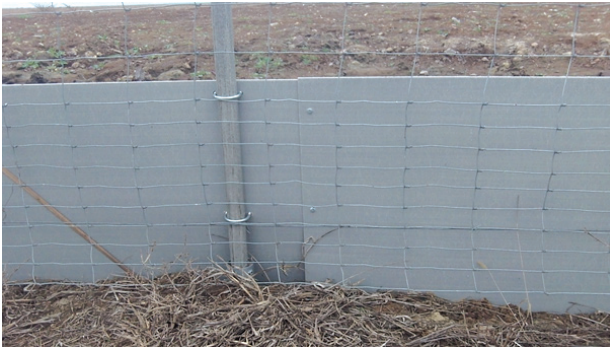
**Fig. 3.** Glass Fiber Reinforced Polymer (GFRP) plates used as barrier for preventing vehicular turtle mortality at the "Trakiya" motorway. Note the stable mounting of the plates to each other and to the metal pole

Because of the drawbacks of concrete as a building material for protection walls, other designs were used during the building of later linear infrastructure objects. On particular sections of Lot 4 of Trakiya Motorway, flat and stiff barriers made of Glass Fiber Reinforced Polymer (GFRP) plates were constructed. The base of the plates was buried 15 cm in the substrate; the plates were connected to each other via metal pins and additionally stabilized by a pole (Fig. 3). The plates were fixed at the bottom of the rabbit fences and represent effective barrier for turtles. This construction is much more appropriate than the concrete walls. The mounting system allows for rapid and uncomplicated repair and exchange of damaged elements. Another important advantage of the plates is that they can also be mounted at the doors for the service vehicles. Despite being more appropriate than the concrete walls, the plate barriers also have some negative aspects. Plastic screens of this kind are vulnerable to mechanical damages (HUIJSER et al. 2008a). The plates also aid in the collection of water at their base (as they are usually lower than the road level and their foundations can be flooded by intensive rainfalls). This may result in destabilization of the rabbit fences and even of other elements of the construction bed including the road itself.

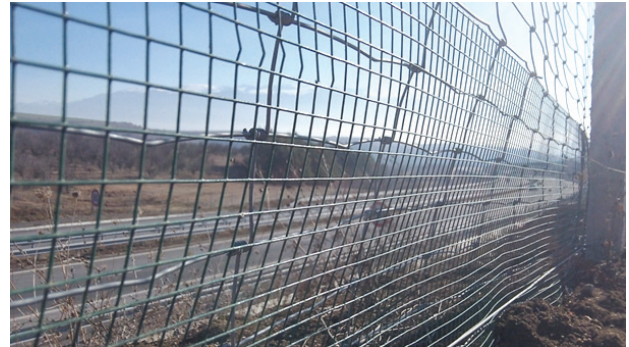
**Fig. 4.** Close-up of the fences constructed at Lot 1 of the Struma Motorway. The fine net is buried deep in the substrate and firmly fixed at the basis of the standard rabbit fence

Fencing by using nets has proven a suitable tool for reducing road mortality in turtles (for overview see ARESKO 2005, HUIJSER et al. 2008a,b). For Struma Motorway, a combined team of experts (including environmental specialists, engineers and designers) introduced to MoEW different designs for protection of turtles based on the use of nets. The approved design was implemented for the first time on Lot 1 of Struma Motorway. As a base, polymer coated sturdy metal nets with a mesh of 10 mm were used. The builders obtained net rolls with a width of 1 m. The rolls were half split in long sections of nets with a height of 50 cm. The net was buried 15 cm in the substrate and the remaining 35 cm were fixed to the standard rabbit nets and slightly tilted outwards from the road (Fig. 4). The design is rather similar to the devices build for protection of turtles (e.g. Gopher Tortoises *Gopherus* sp. and Alabama Red-Bellied Turtle *Pseudemys alabamensis*) in USA (HUIJSER et al. 2008a). This construction possesses several important advantages over the wooden, concrete and plastic alternatives. First, it is very strong and durable. It cannot be damaged by the turtles and other small animals, whilst it is flexible and can be adapted to the irregularities of the terrain. The net is protected from rust by a plastic coating and has a twelve-year warranty from the producer. The most

important advantage of the net is that it does not collect rain water and there is no need of drainage system.
